2-207 INSPECTION OF AIRCRAFT
STRUCTURES USING MOBILE SOURCES;
A COMPENDIUM OF RADIOGRAPHIC
RESULTS

Training & Servicing/Armament Division
Naval Support Equipment Department
Naval Air Engineering Center
Lakewood, New Jersey 08730

16 APRIL 1979

Final Report for Period 15 May 1977 - 31 December 1978
NAVEDP 2000000-790000-41001-000

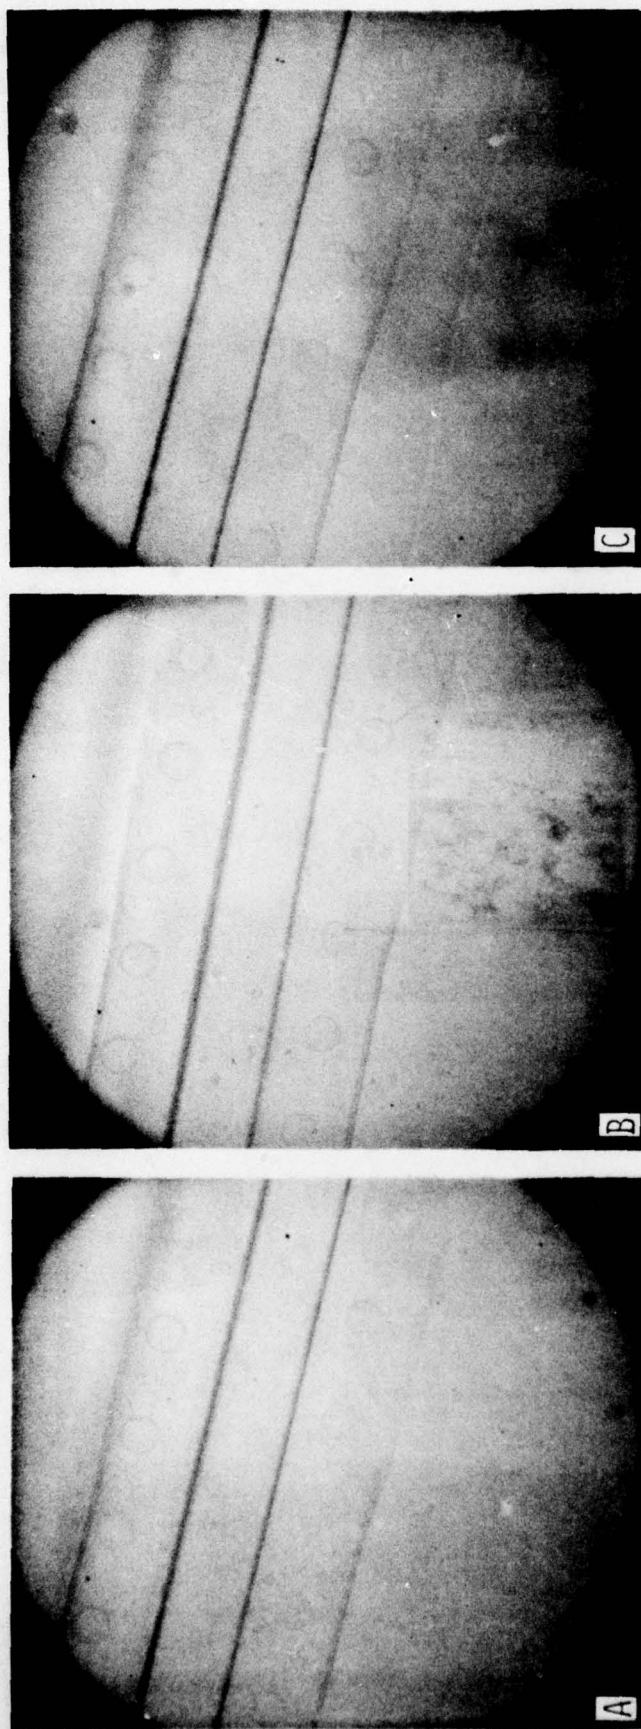
Figure 29 - Neutron Radiographs of a C-2 Vertical Fin, and Fin With Corrosion Penetrameter Attached

Radiographs of a C-2 vertical fin section (A), and of a corrosion penetrameter attached to the fin (B,C) are shown. The penetrameter was of aircraft-grade aluminum with nominal step thicknesses 0.125 and 0.87 inch, prepared by subjection to a supersaturated salt water spray for 6.5 hours to induce corrosion attack. Radiographs B and C were obtained with penetrameter on the cassette side and neutron source side of the vertical fin, respectively. Due to the substantial separation (7 inches) of the penetrameter from the film cassette in C, the corrosion pattern is unresolved in that radiograph, suggesting that for such thicknesses (greater than ~1 inch) each side should be inspected individually.
